June 28, 2019
File No. 262018.063

Subject: Department of Natural Resources Washington Geological Survey,
School Seismic Safety Assessment Project, Contract No. AE 410 -
Seismic Evaluation for **Longview School District**

School Buildings Evaluated in the Longview School District

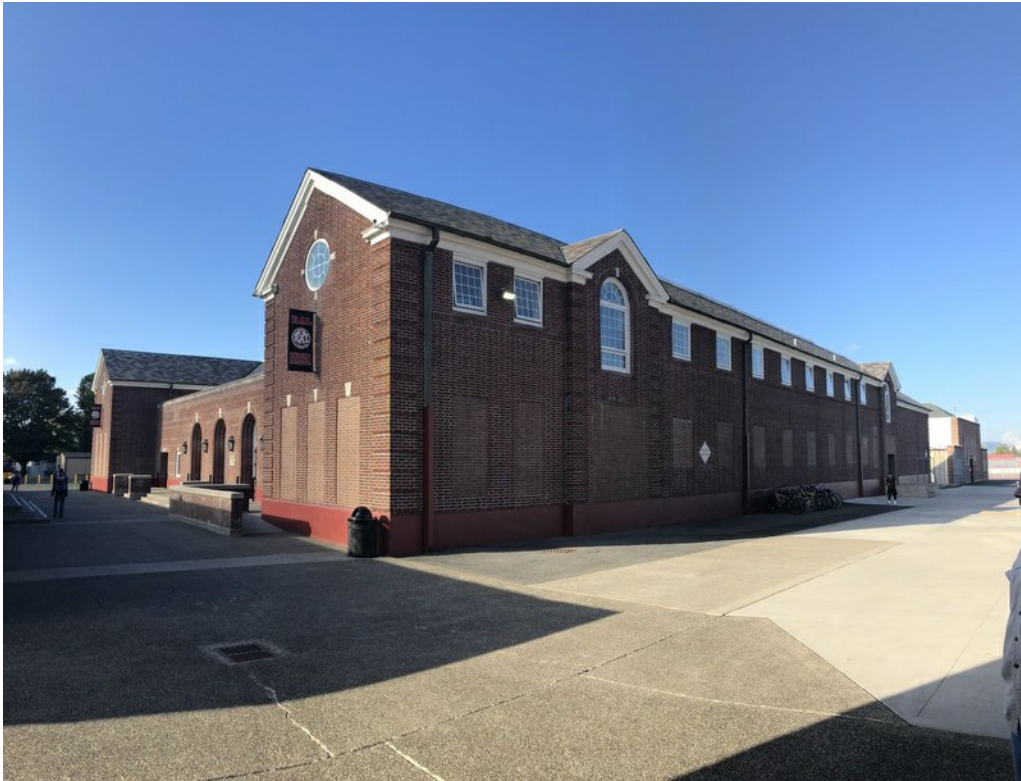
Figure 1-1. R.A. Long Gym Building - Northeast Corner

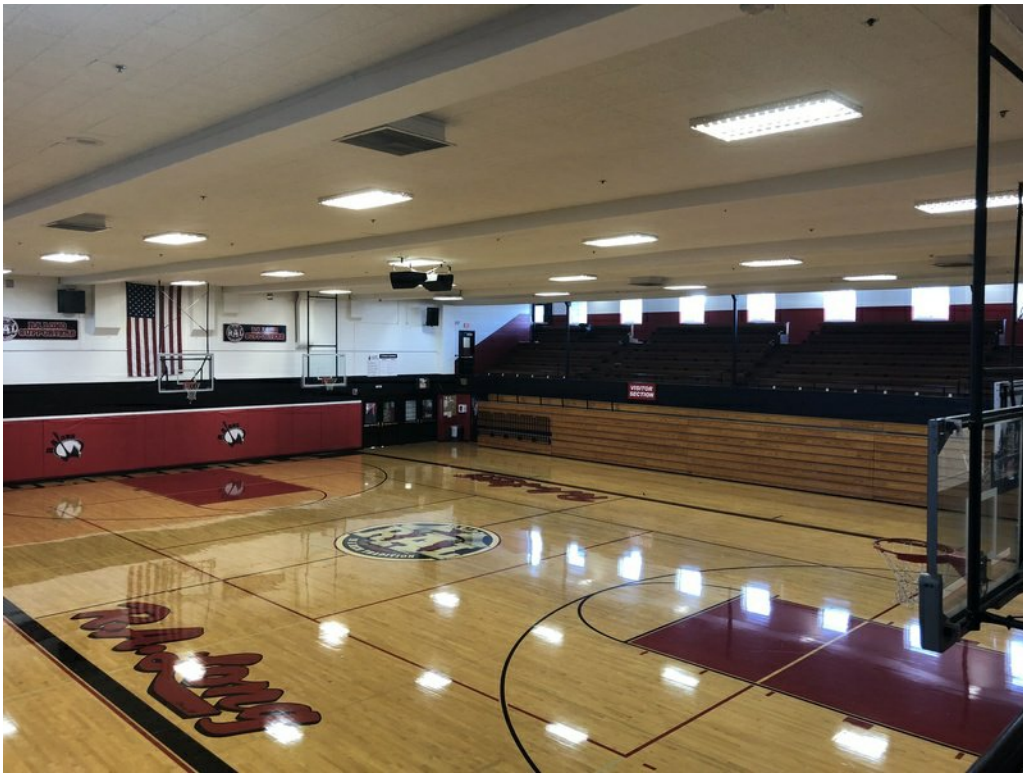
Figure 1-3. Main Gymnasium

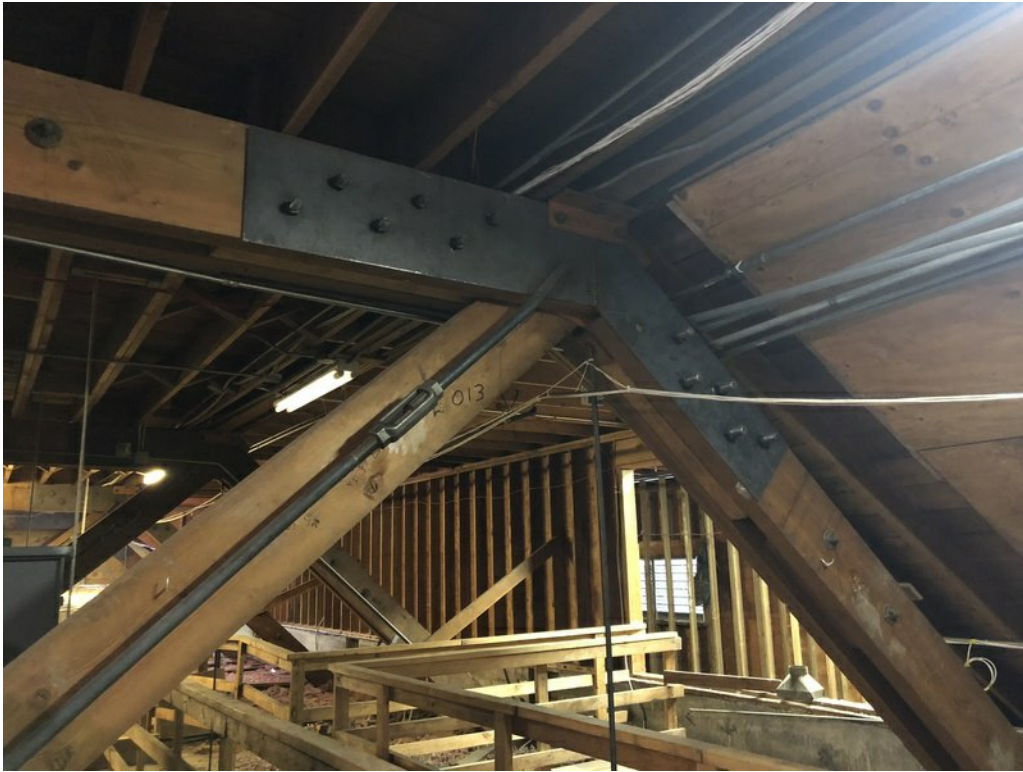
Figure 1-5. Main Gymnasium Attic Space

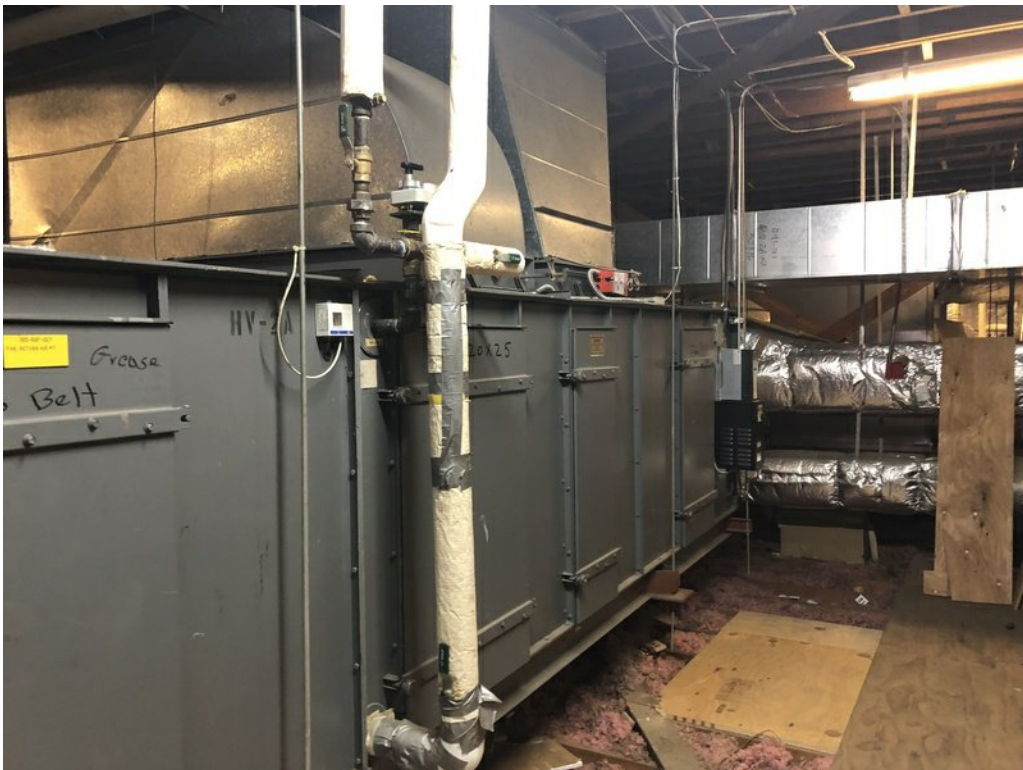
Figure 1-6. Mechanical Equipment and Ducts in Attic Space

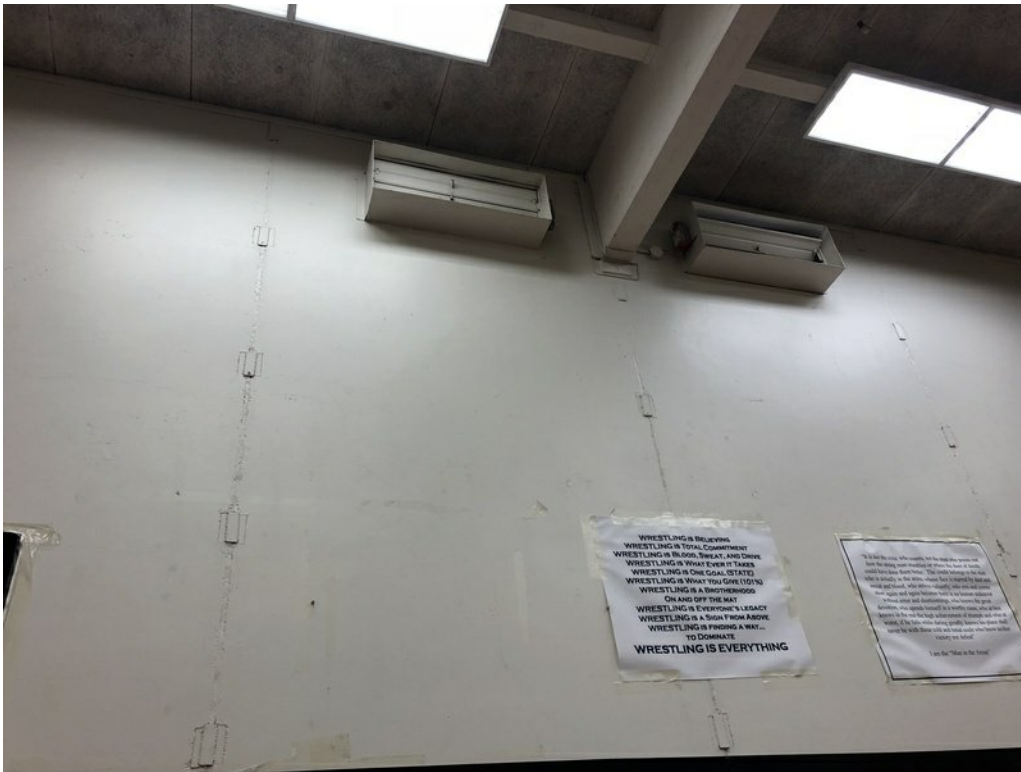
Figure 1-8. Precast Panel Walls at Annex Building

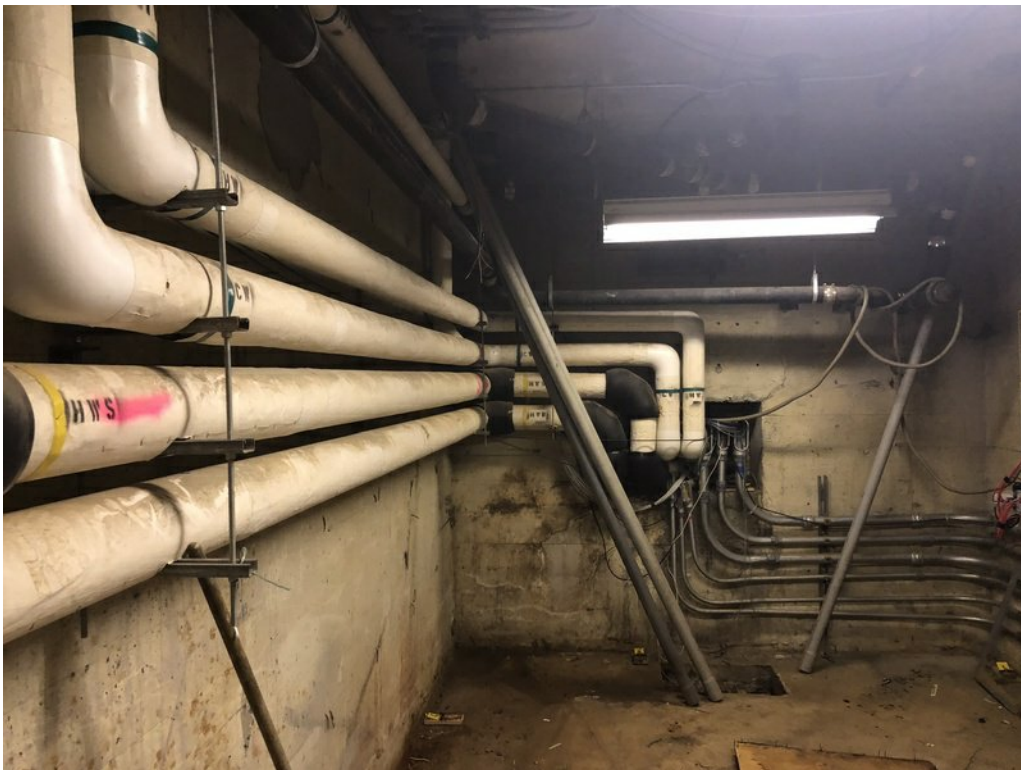
Figure 1-9. Pipes at Main Gymnasium Basement

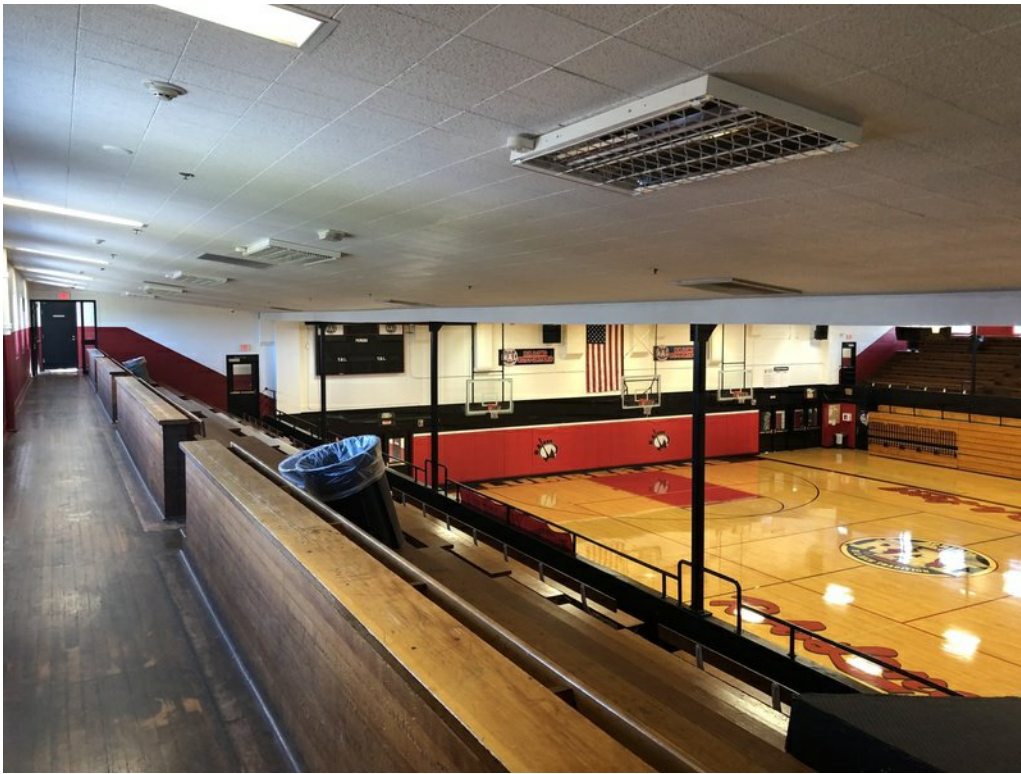
Figure 1-10. Main Gymnasium at Interstitial Level

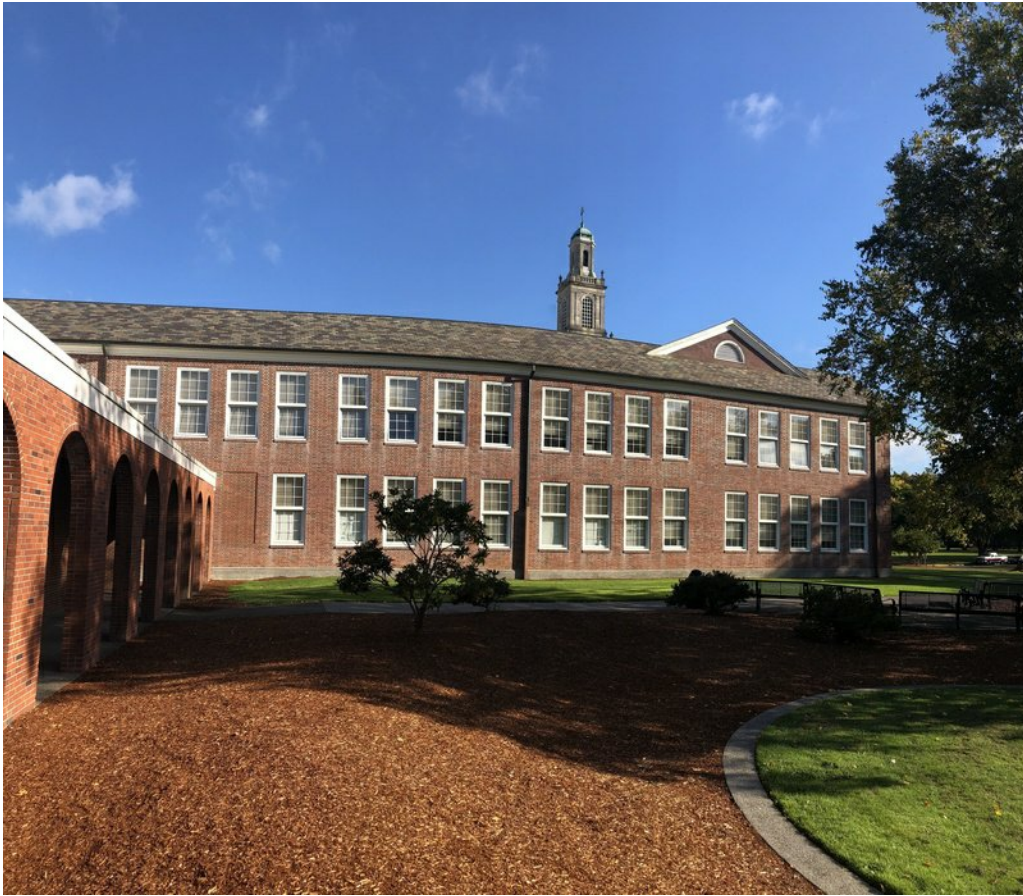
Figure 1-2. R.A. Long High School - South Exterior

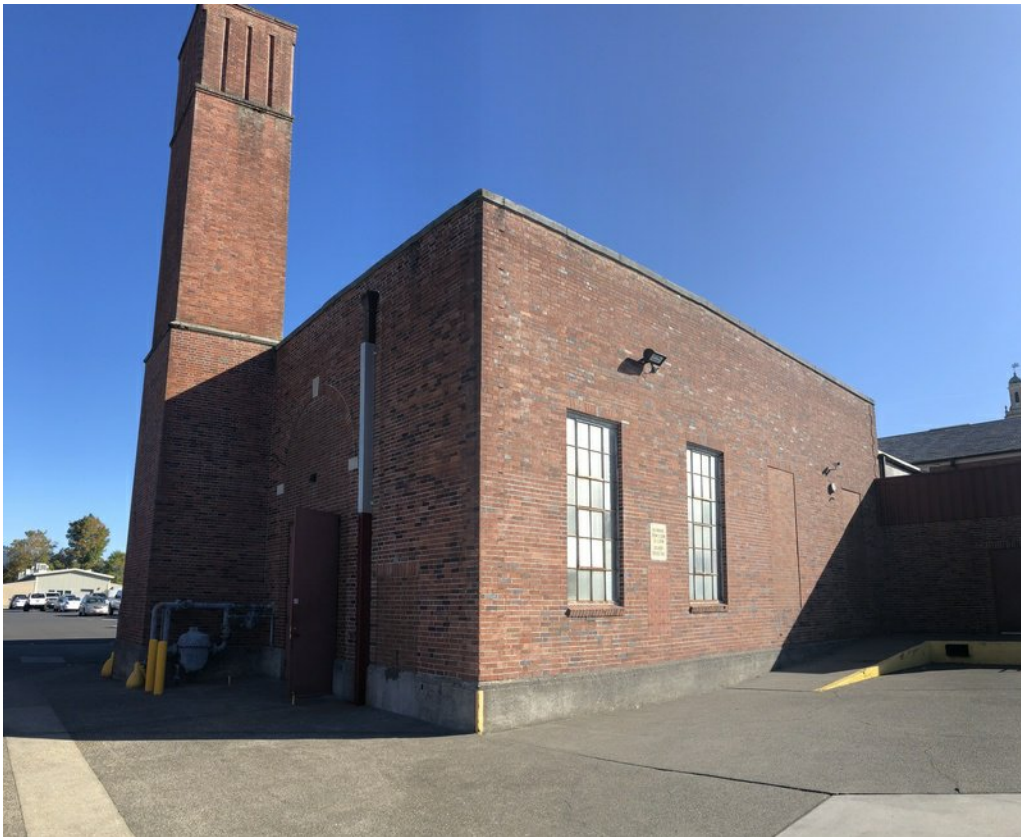
Figure 1-3. R.A. Long High School - West Exterior at Boiler Room

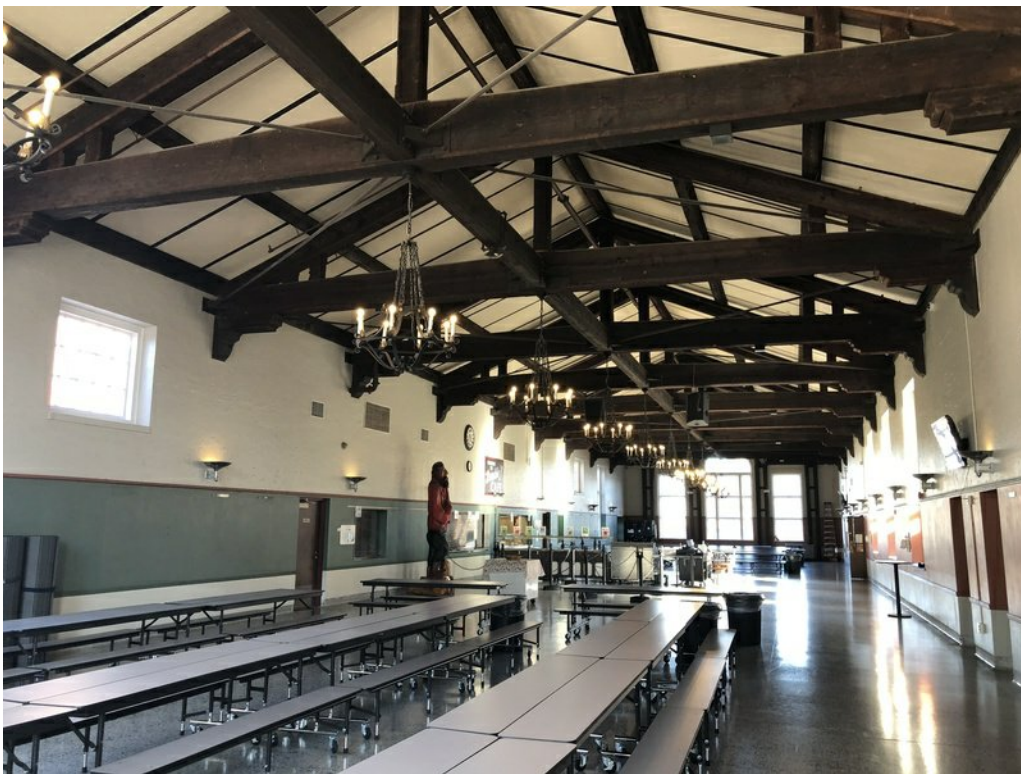
Figure 1-4. Timber Trusses in Cafeteria

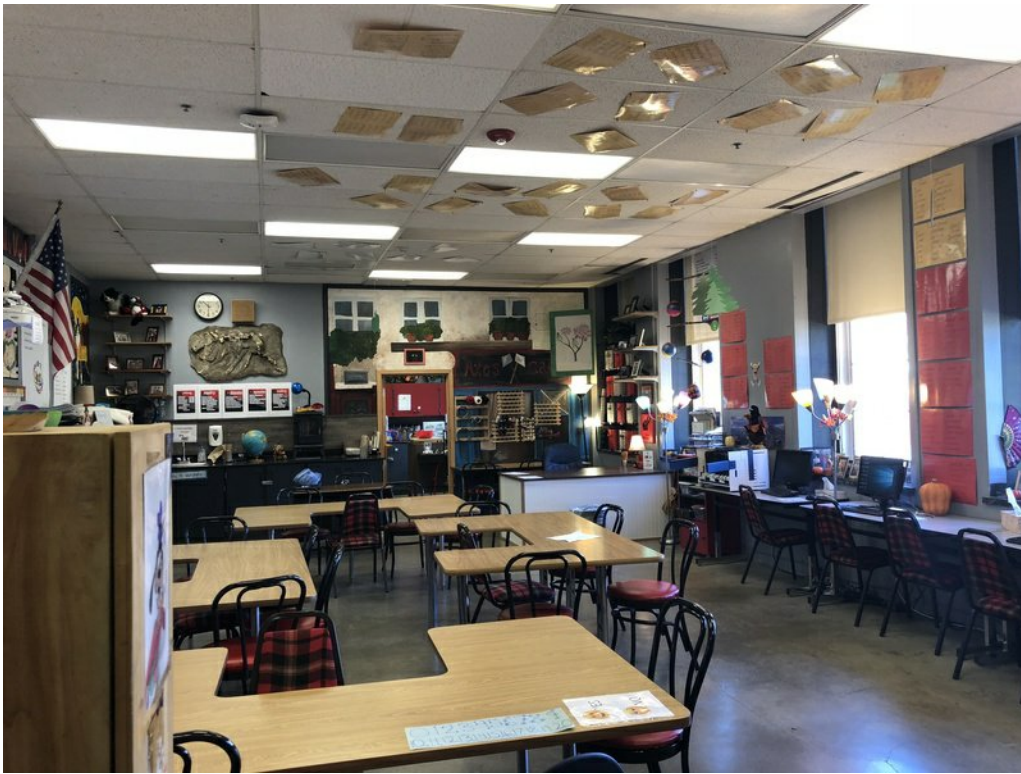
Figure 1-5. Typical Classroom with Unknown Light Fixture Bracing

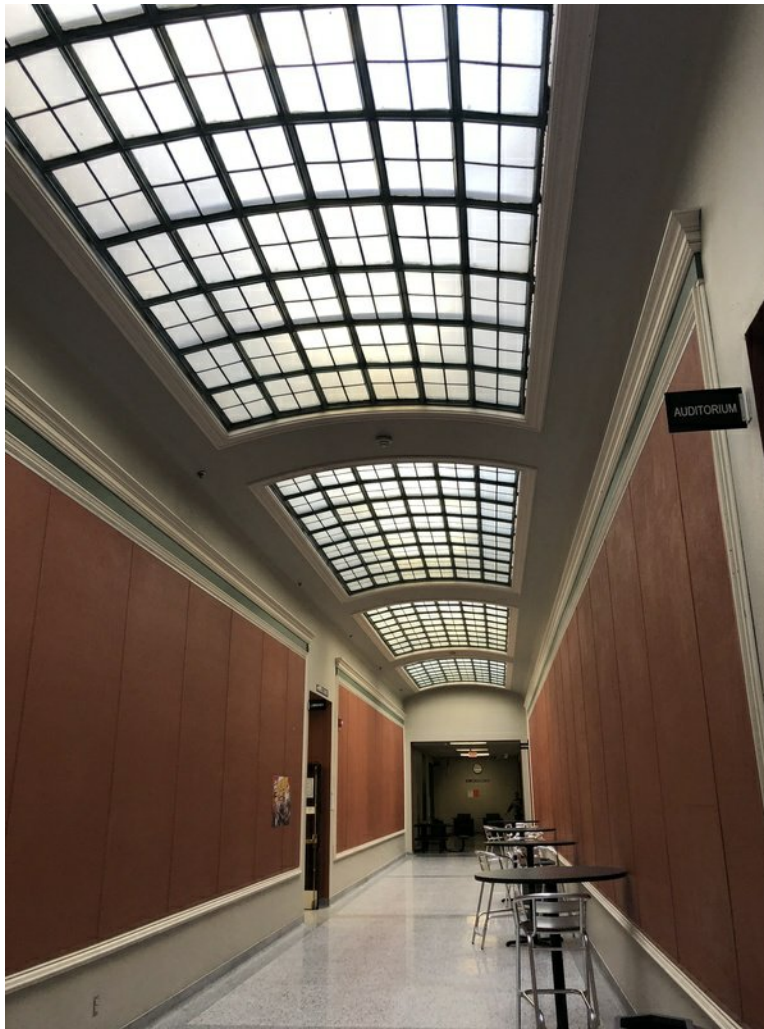
Figure 1-8. Skylights in Upper Level East Hallway with Unknown Detailing Could Present Falling Hazard

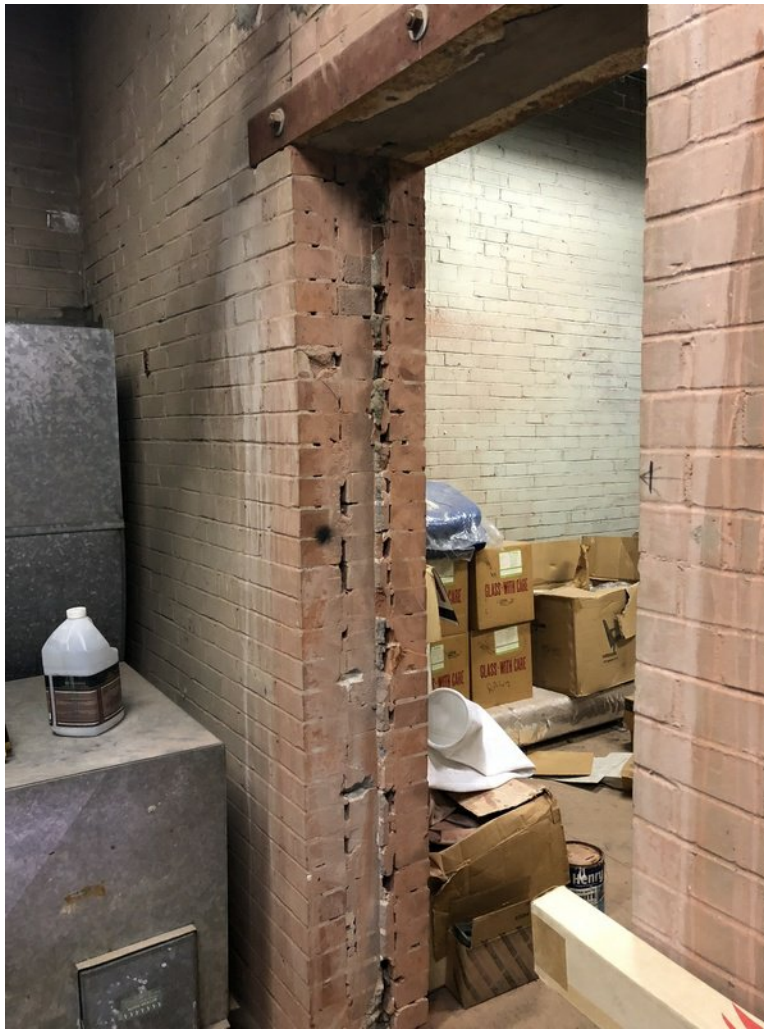
Figure 1-9. Opening Showing Unreinforced Multiple-Wythe Brick Wall

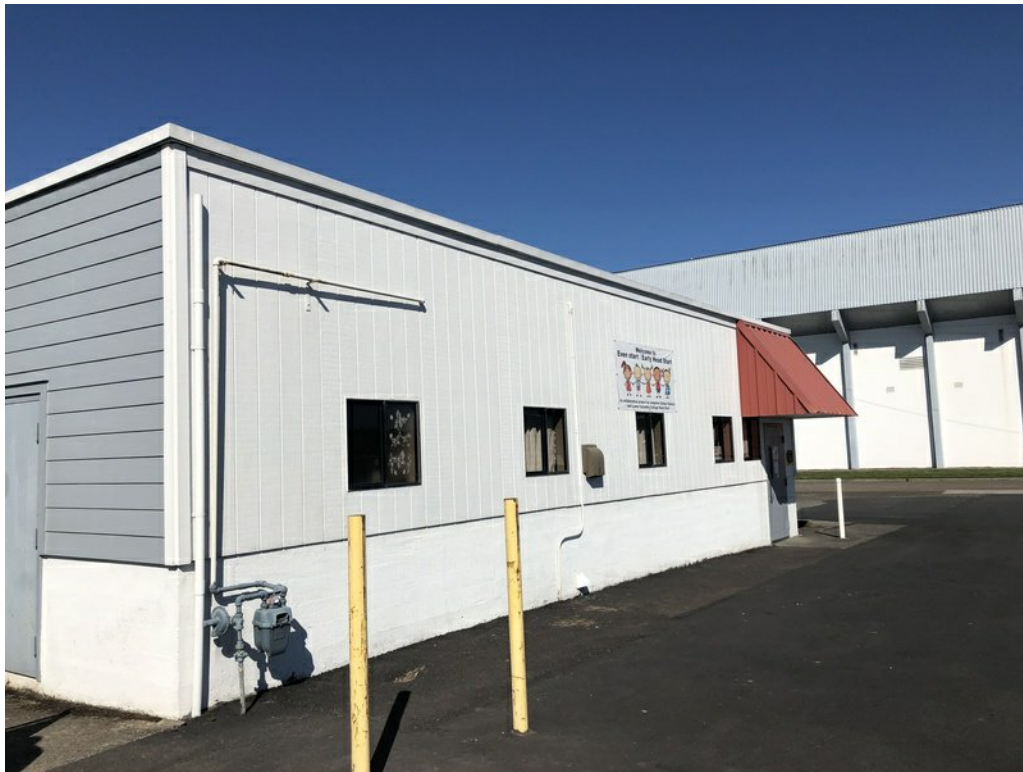
Figure 1-1. R.A. Long Annex - East Exterior

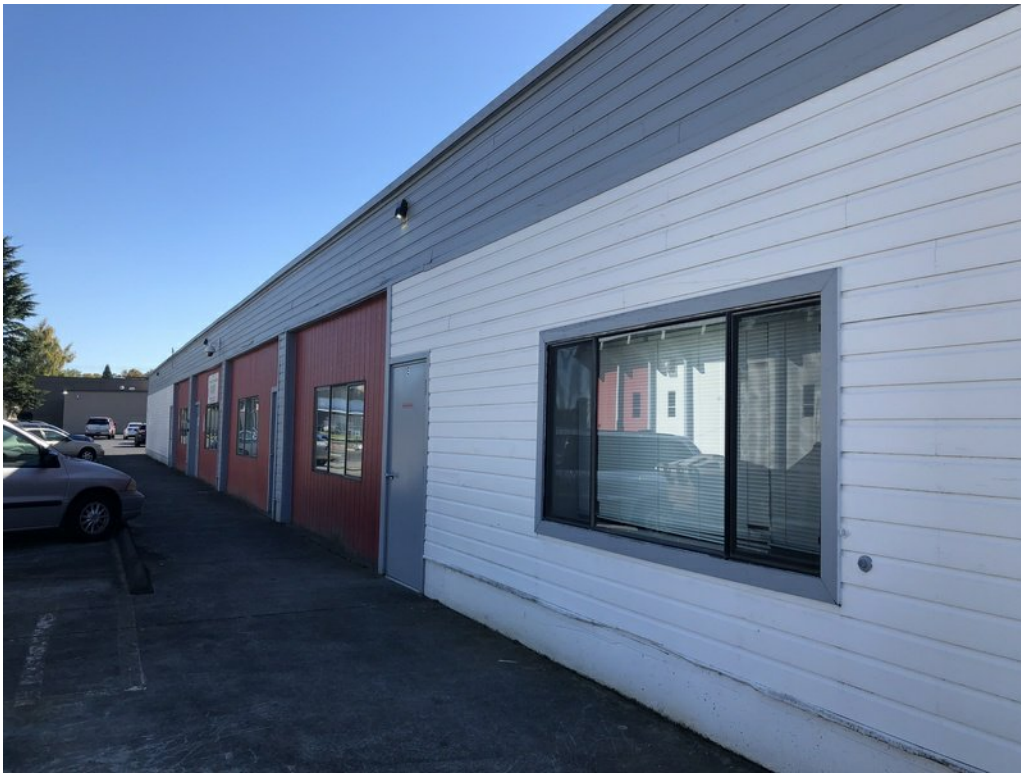
Figure 1-3. R.A. Long Annex - North Exterior with Infilled Garage Bays

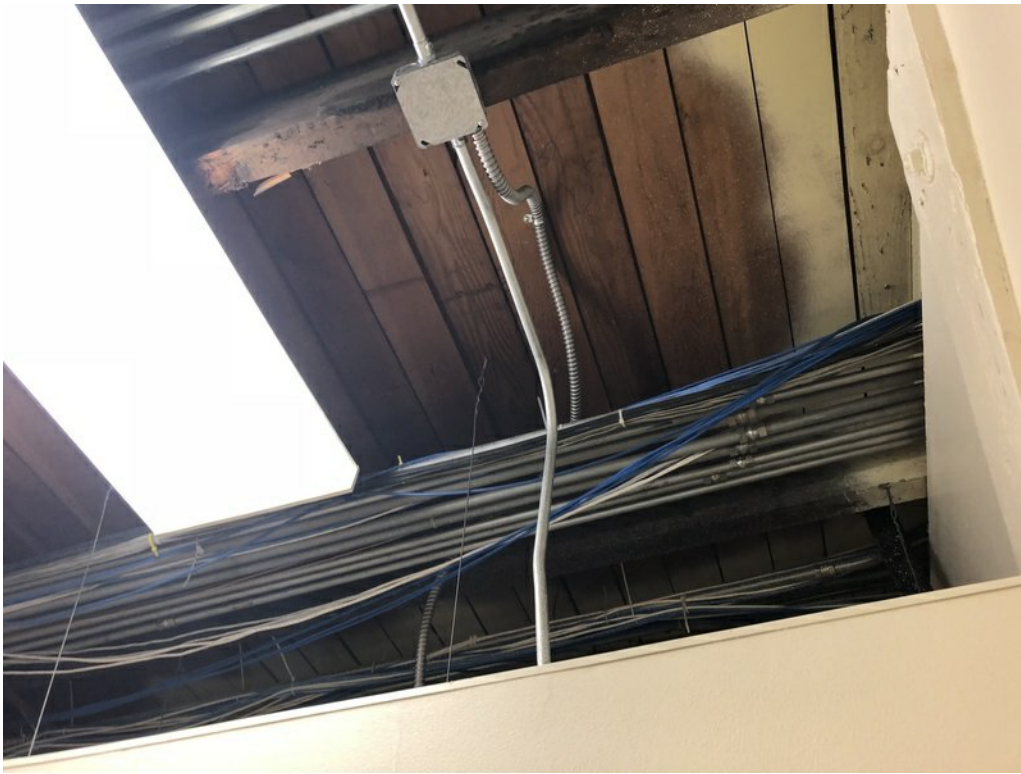
Figure 1-6. Straight Sheathing at Roof Diaphragm

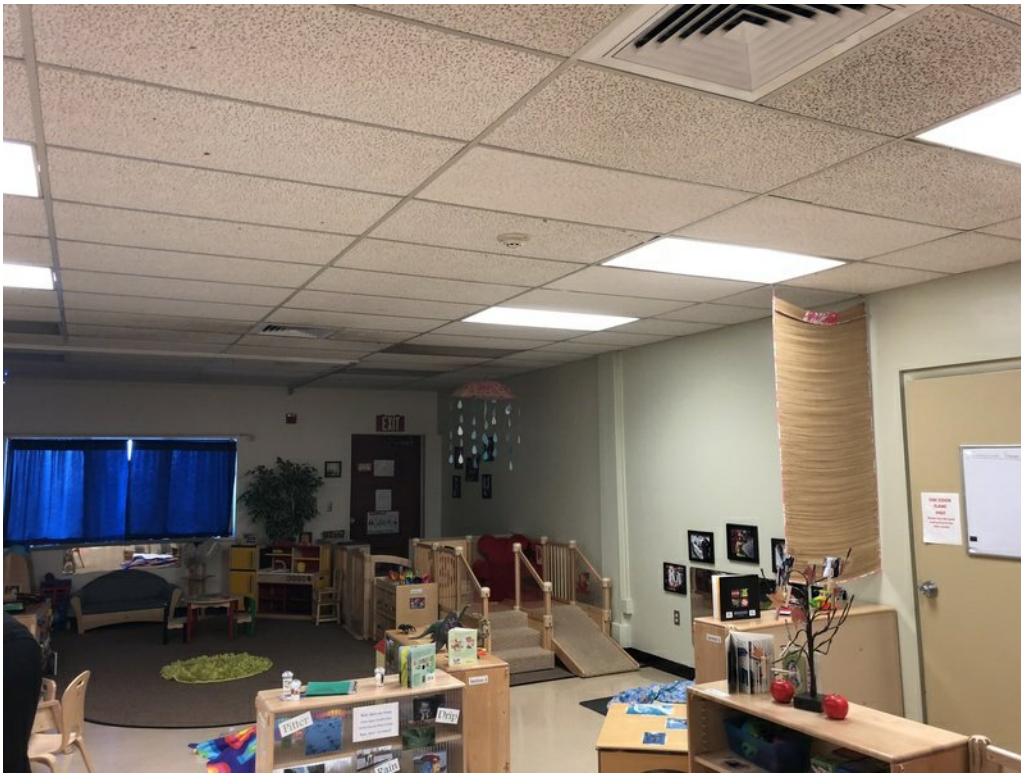
Figure 1-8. Typical Classroom with Unknown Light Fixture Bracing

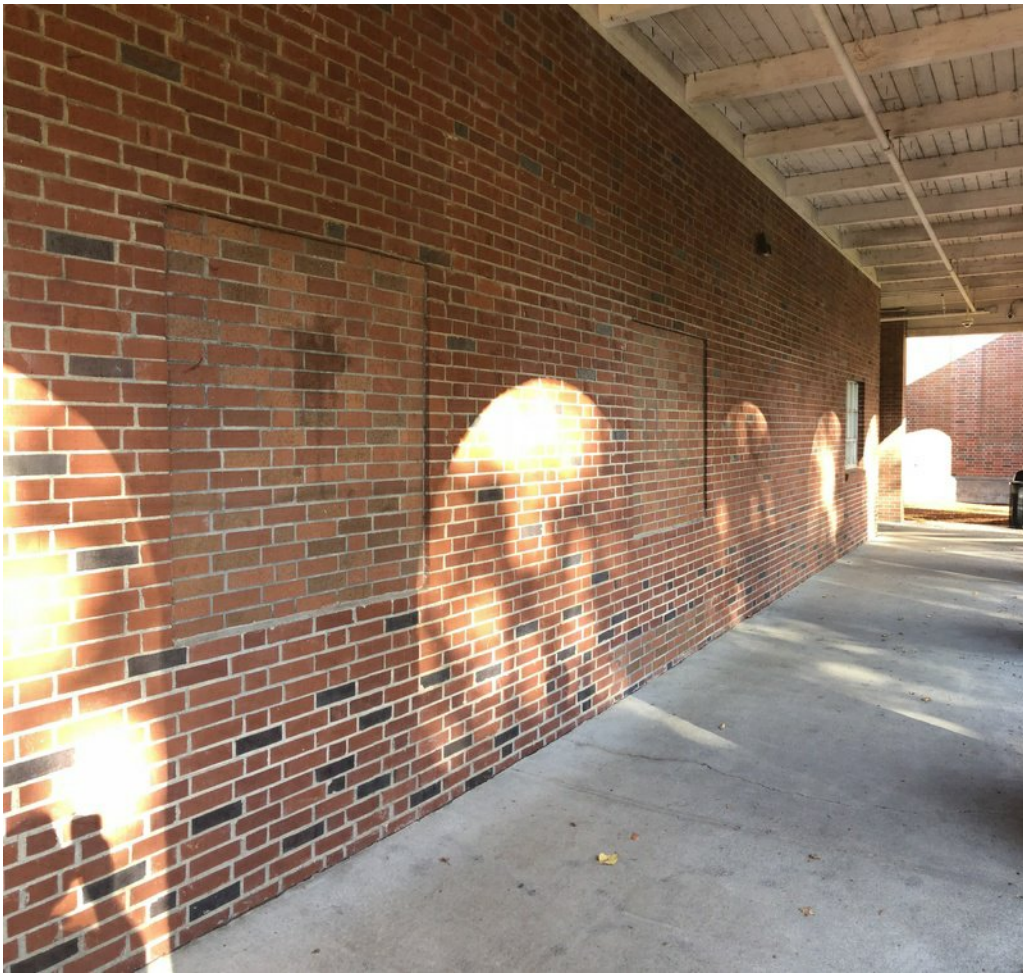
Figure 1-6. Infilled Windows at Exterior

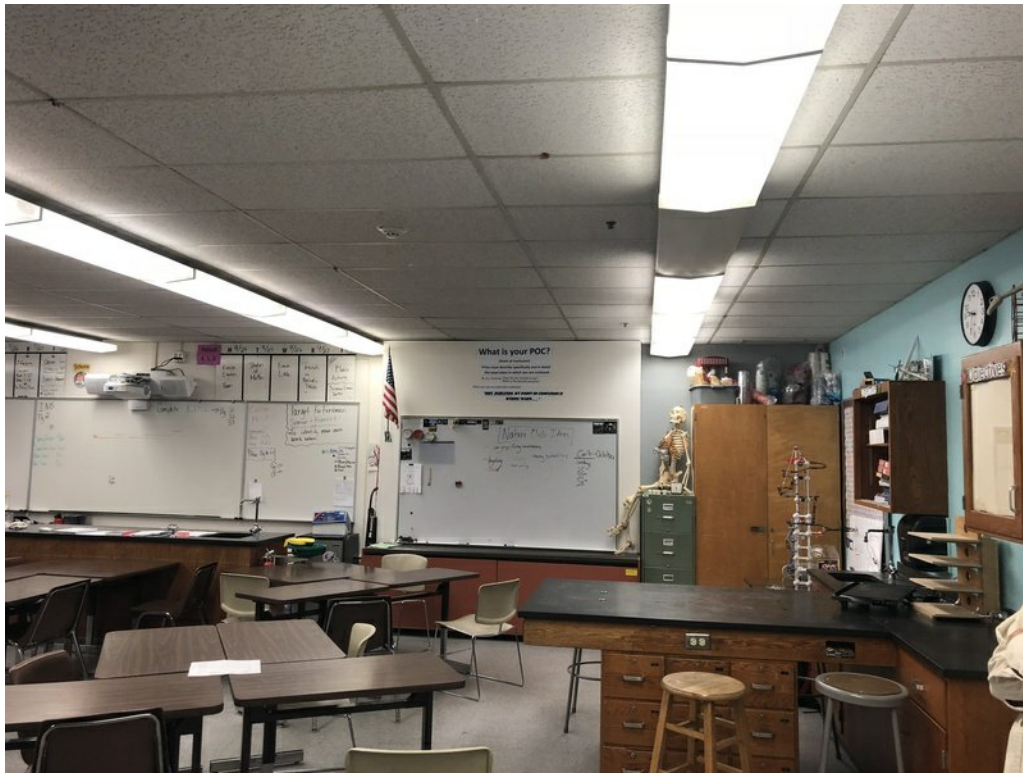
Figure 1-7. Typical Classroom with Inadequate Fire Sprinkler Head Penetration Clearance, Typical Throughout

Deficiency	Description
LSS-5 Sprinkler Ceiling Clearance. HR-not required; LS-MH; PR-MH.	Inadequate penetration clearances at panelized ceilings for fire suppression devices. Provide clearance around sprinkler head or provide flexible lines between horizontal piping and sprinkler heads.

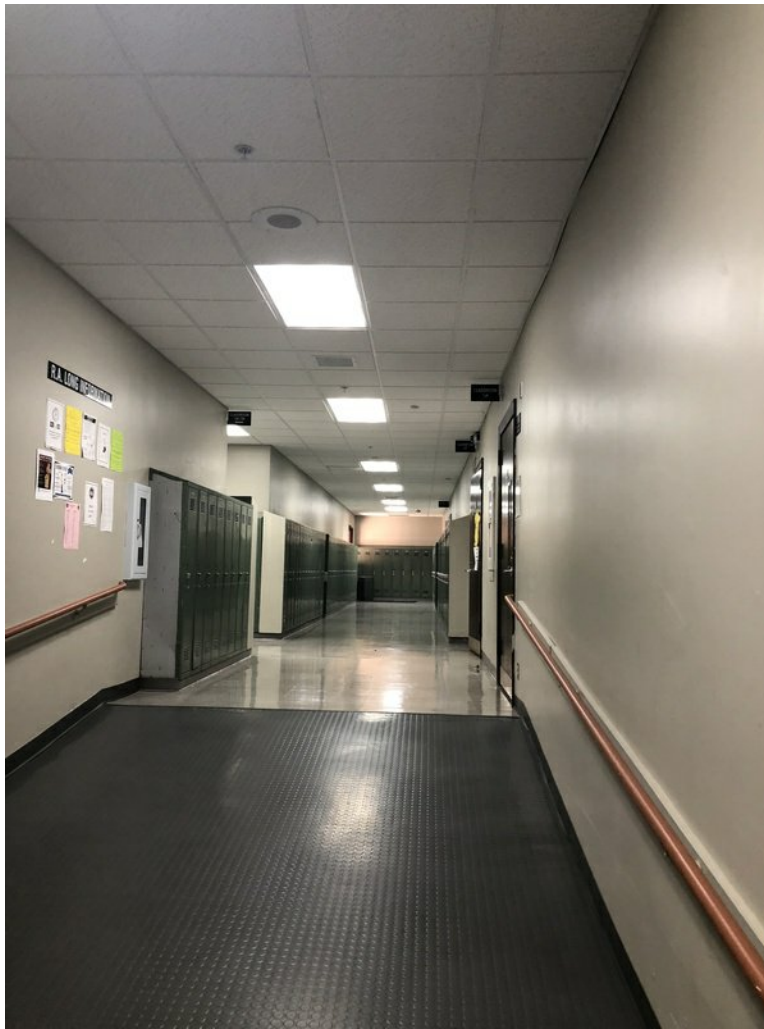
Figure 1-8. Entrance at West Side. Unknown Light Fixture Bracing, Typical.

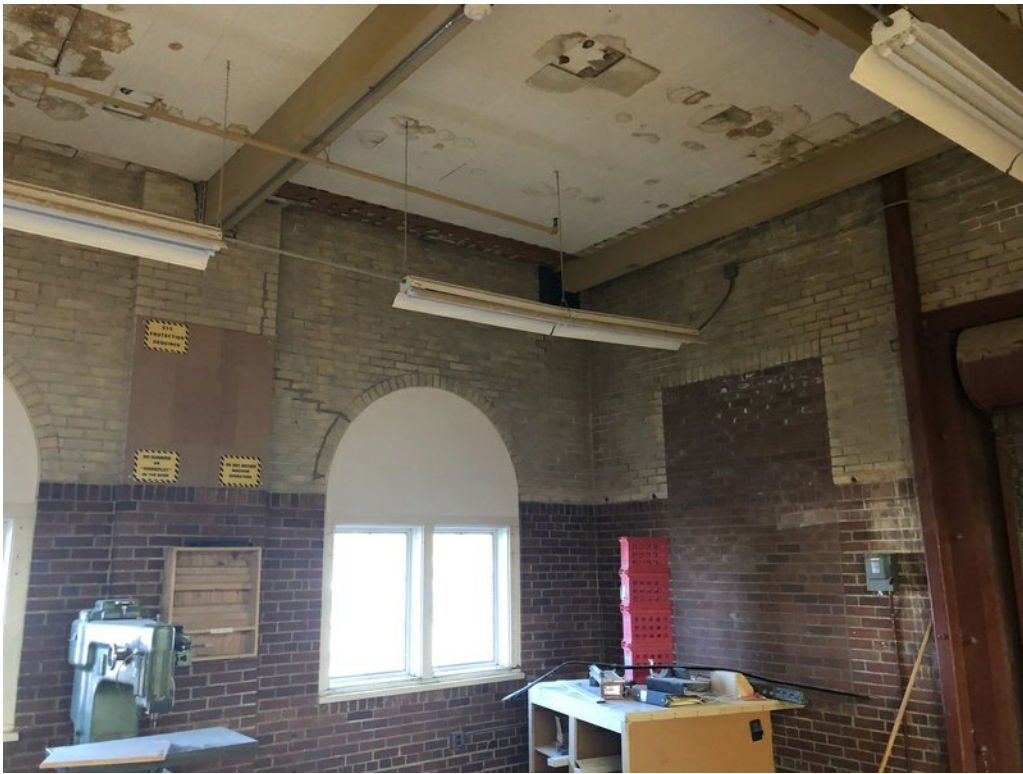
Figure 1-5. Evidence of Cracking in Masonry Wall

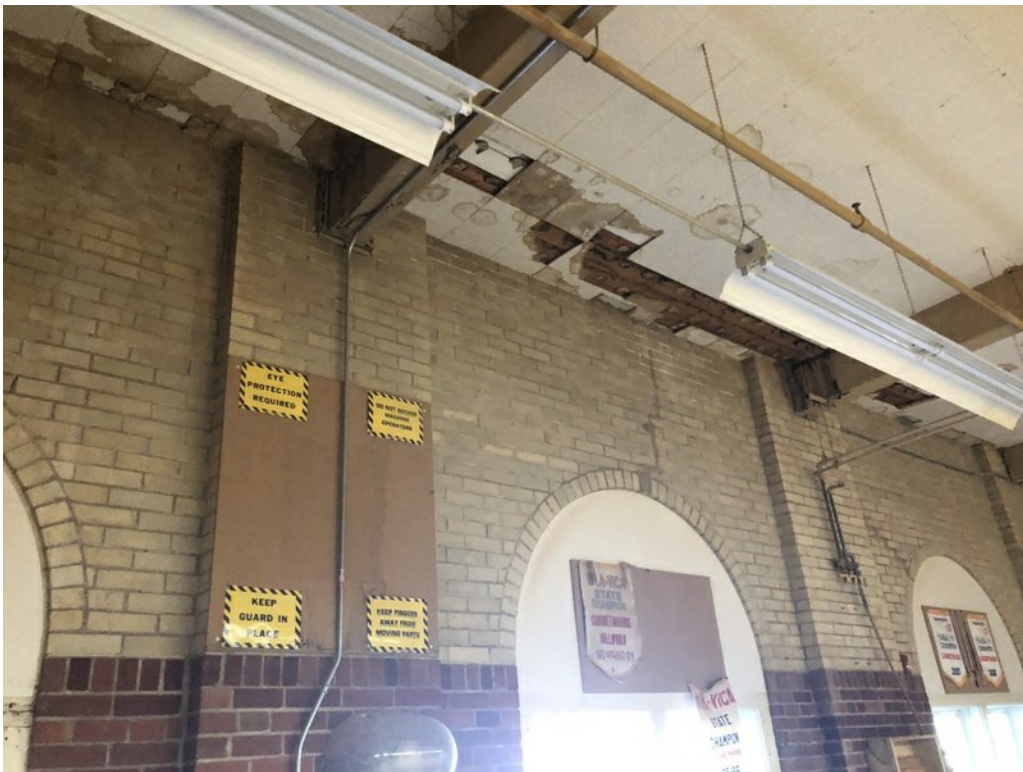
Figure 1-6. Evidence of Water Damage at Ceiling

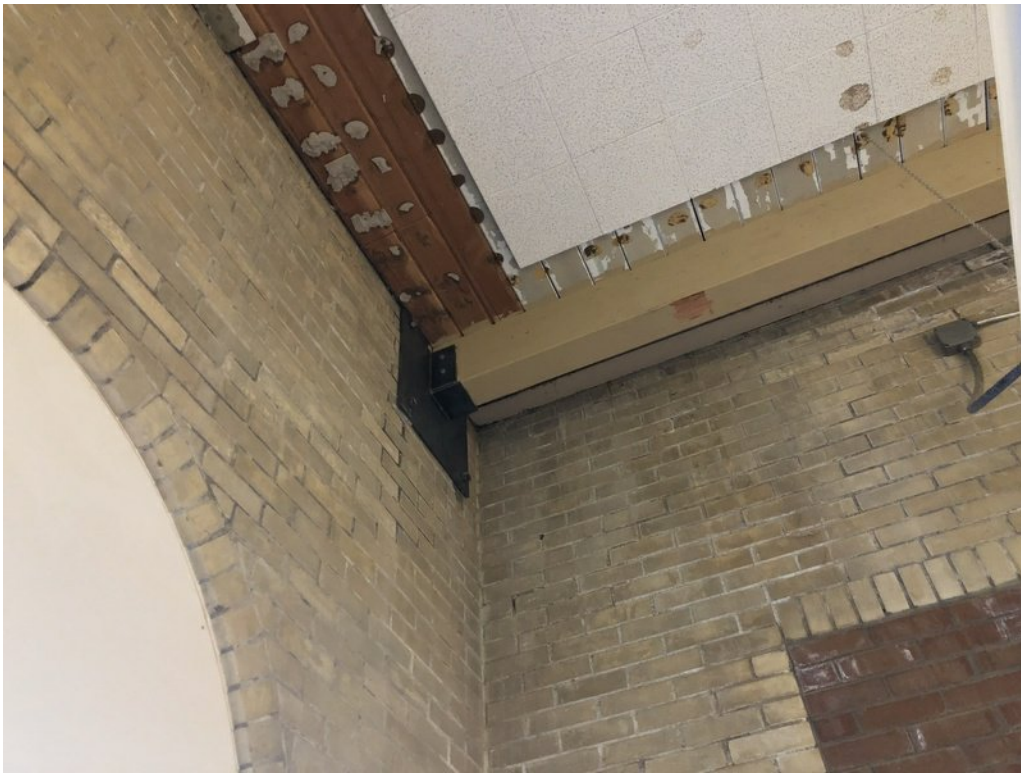
Figure 1-7. Wood Beams Supported by Masonry Wall Only
